Report of Structural Integrity Reserve Study

**QUATTRO AT NAPLES SQUARE CONDOMINIUM
ASSOCIATION, INC.**

**1130 3rd Avenue S,
Naples, Collier County, Florida**

**SOCOTEC Project Number 7167-001.01
April 2023**

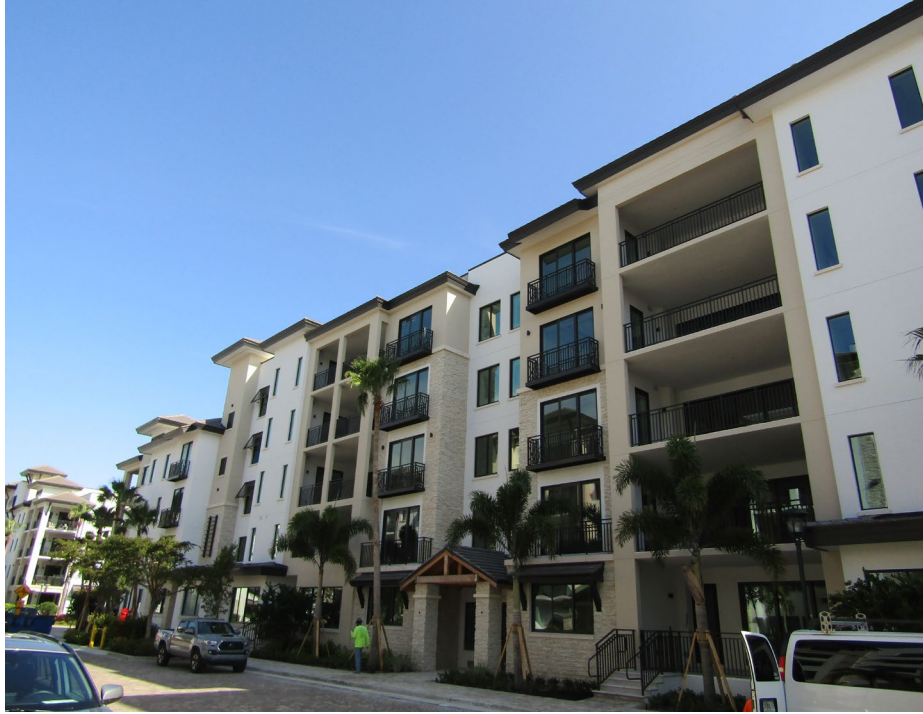
Photo 1 – Partial East/West elevation.

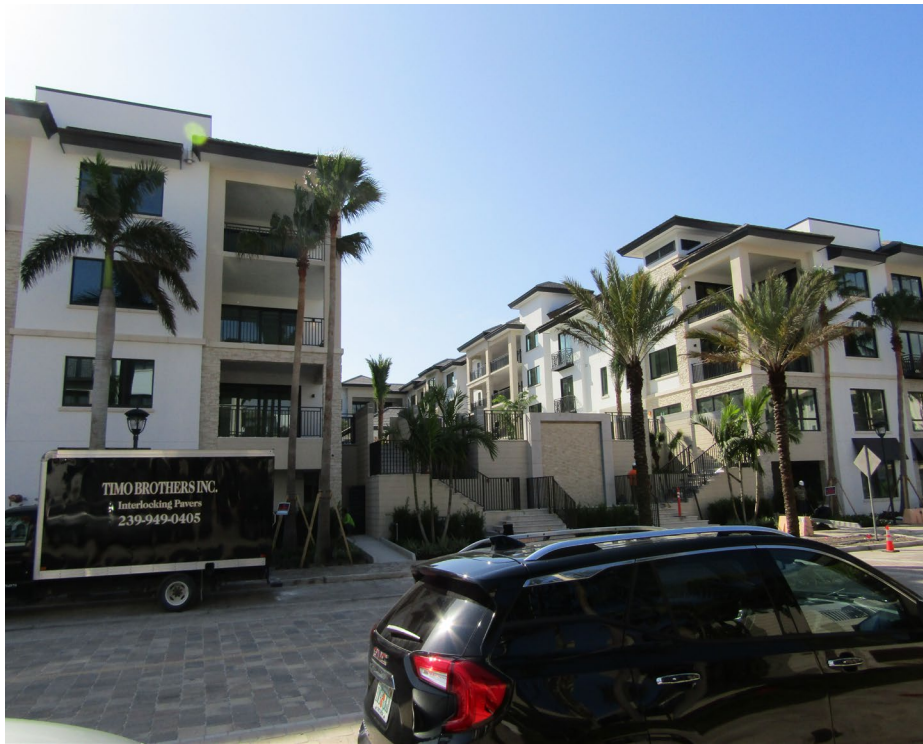
Photo 2 – Partial North elevation.

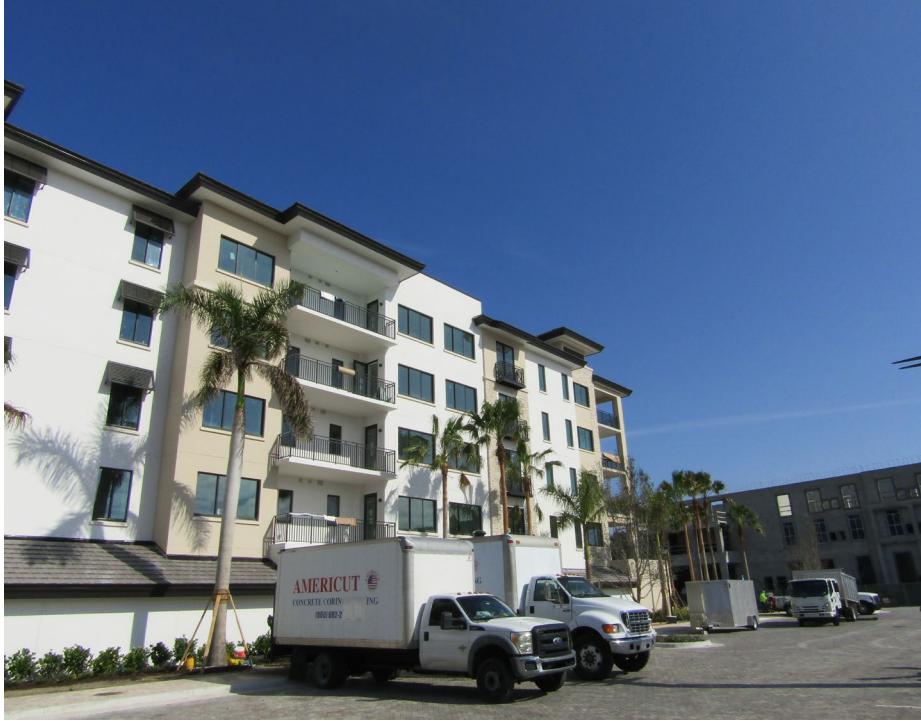
Photo 3 – Partial South elevation.

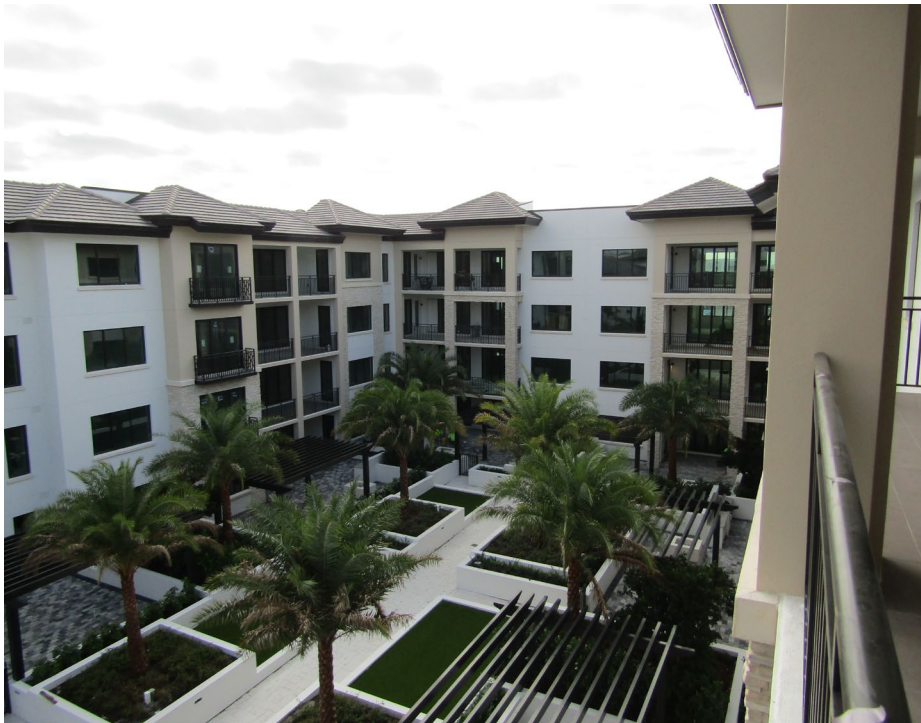
Photo 4 – Partial view of interior East/West elevation.

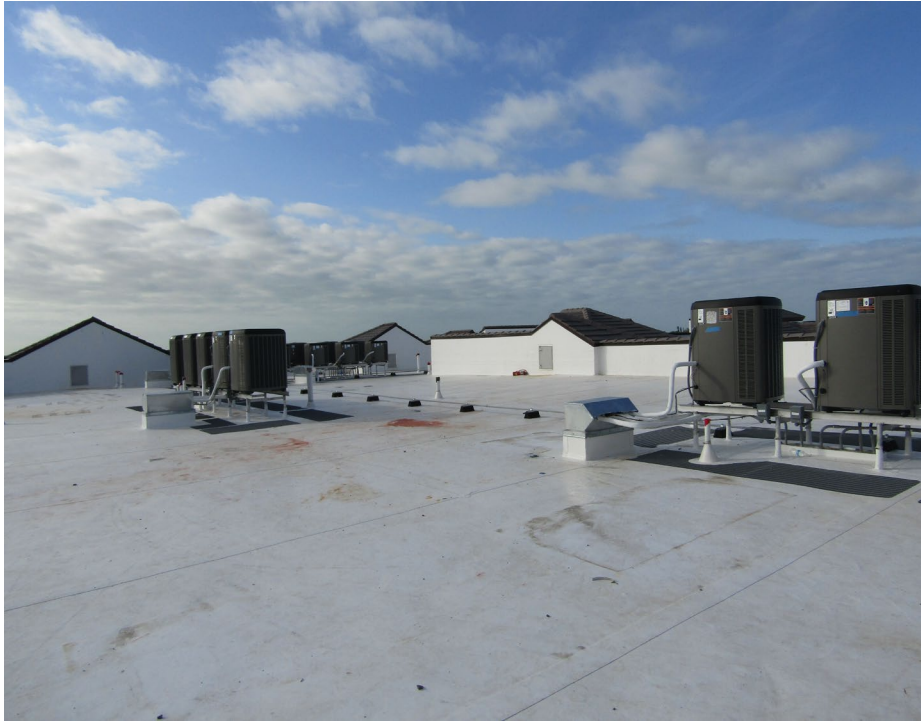
Photo 5 – Partial view of TPO roof system.

Thermoplastic Polyolefin Flat Roofs – The building roofs consist of a Thermoplastic Polyolefin (TPO) system. The roofs were installed circa 2022 and typically have a useful life of 20 years under normal operating conditions with routine yearly maintenance. At the time of our site visit, the roof system was observed to be in good overall condition. We have included a reserve item for the roofs and should be scheduled for replacement circa 2042.

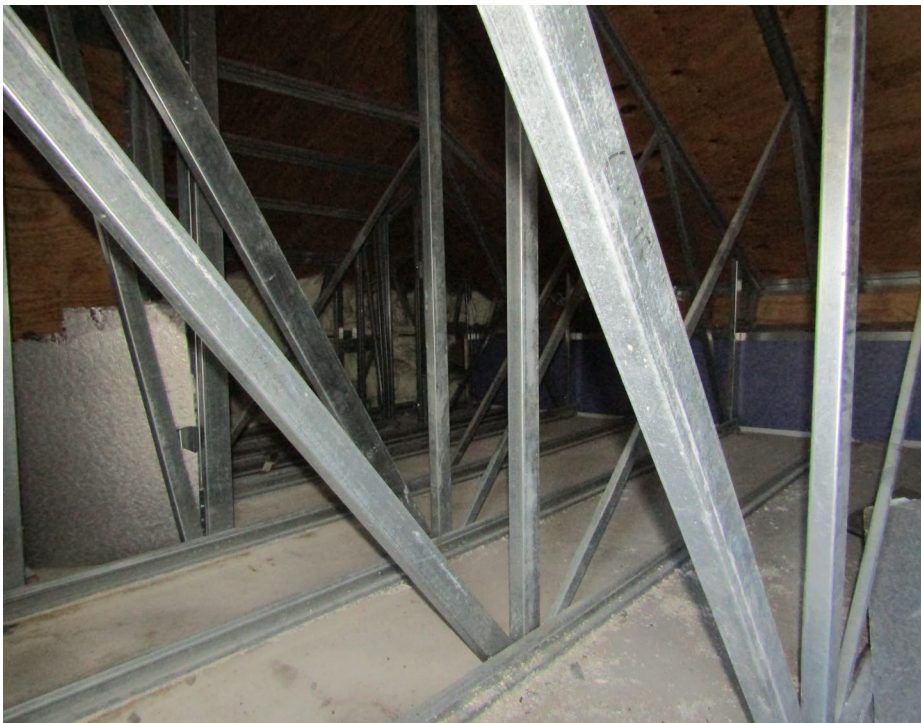
Photo 6 – Interior view of hip roof.

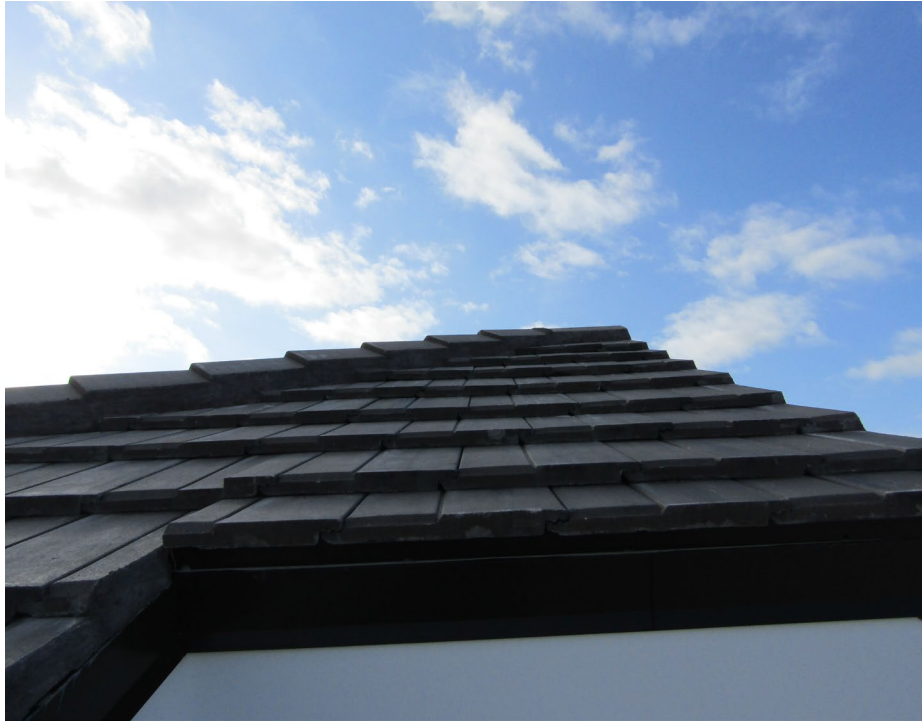
Photo 7 – View of typical concrete tile hip roof system.

Concrete Tile Roofs - Portion of the building roof consist of a concrete roof tile system. This type of roof system typically has a useful life of 25 years under normal operating conditions with routine yearly maintenance. The roof was installed in 2022. At the time of our site visit, the roof system was observed to be in good overall condition. We have included a reserve item for replacement of the roofs.

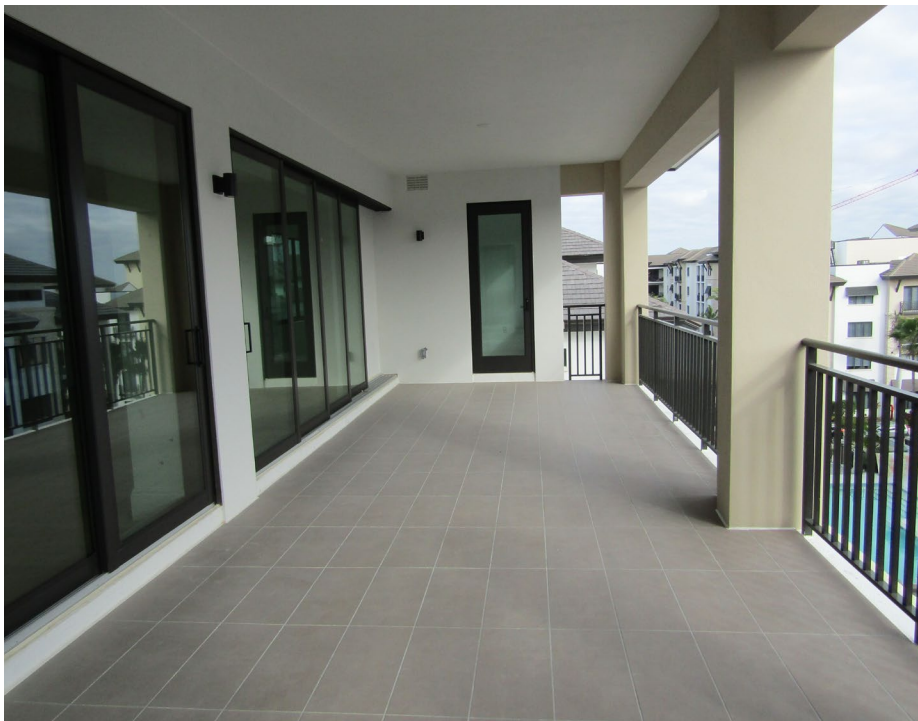
Photo 8 – View of typical interior East/West terrace.

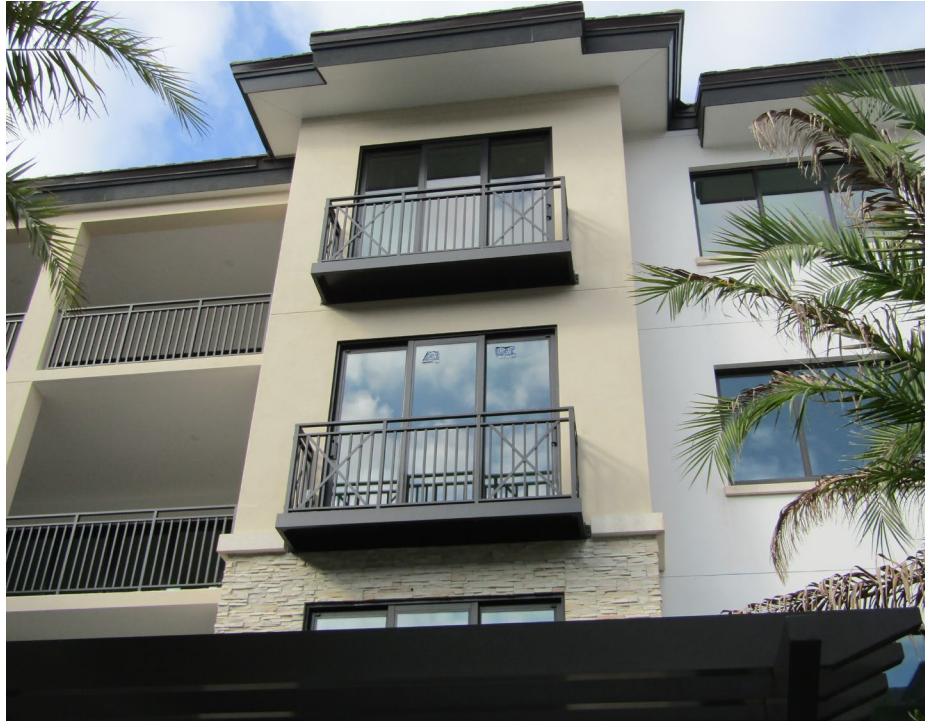
Photo 9 – View of typical pre-engineered Juliet balconies.

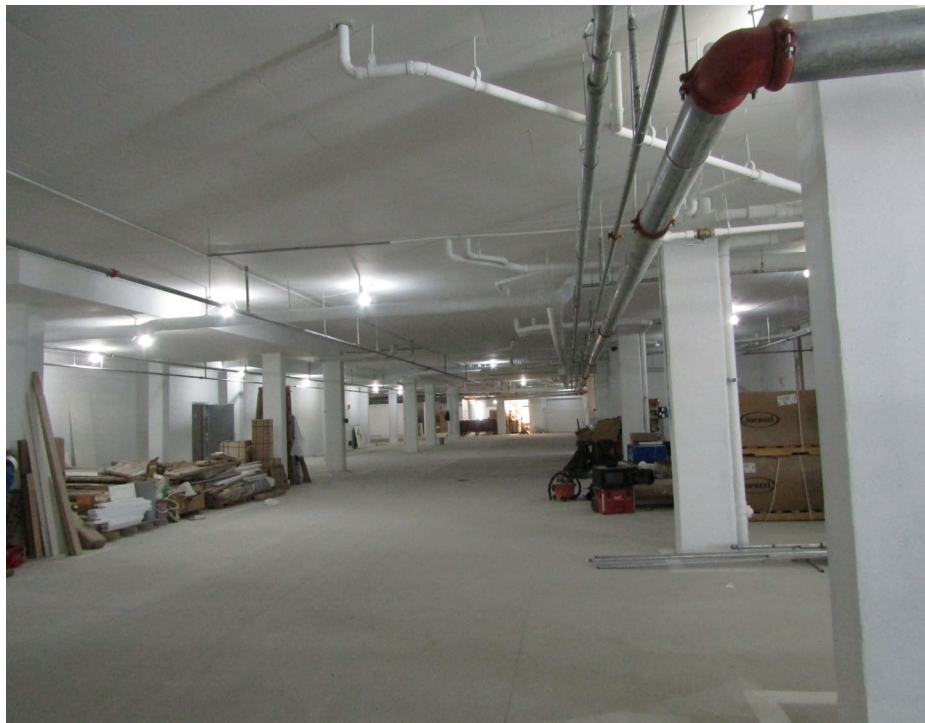
Photo 10 – Partial view of Parking garage.

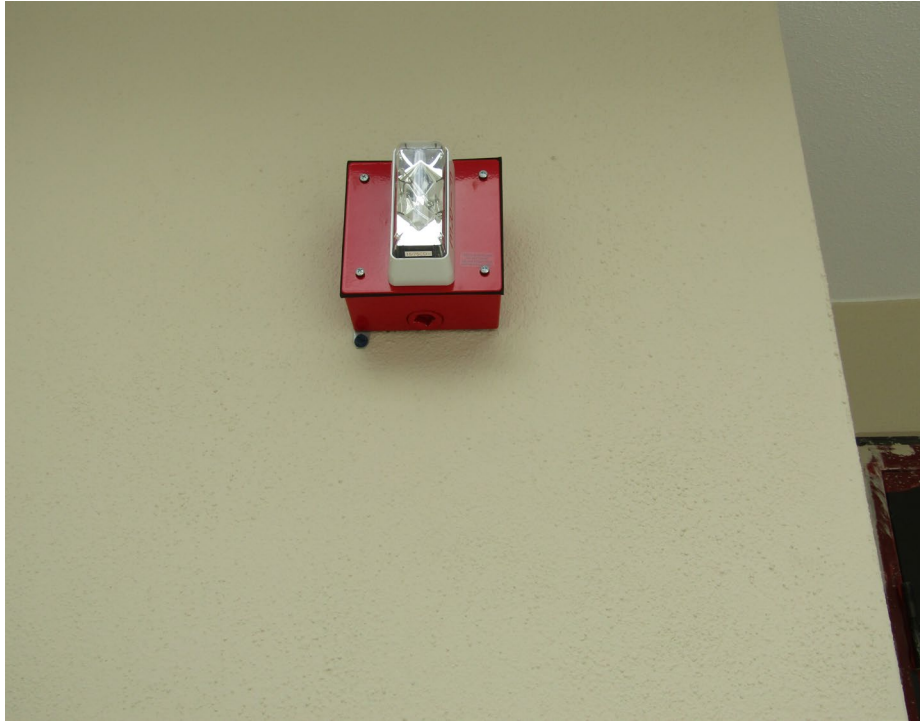
Photo 11 – View of typical fire alert throughout the building.

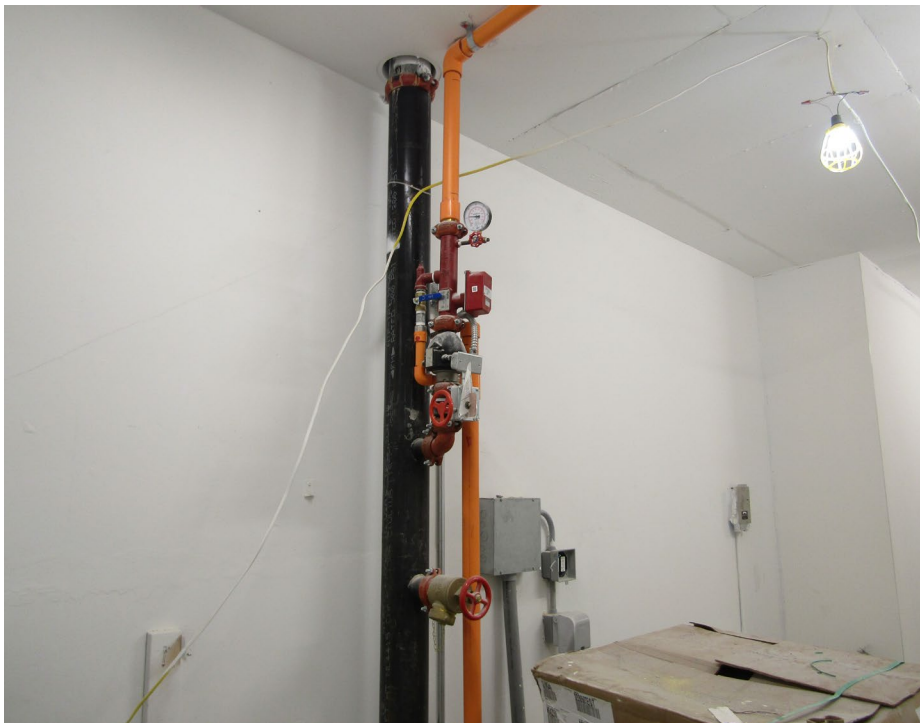
Photo 12 – View of fire safety system.

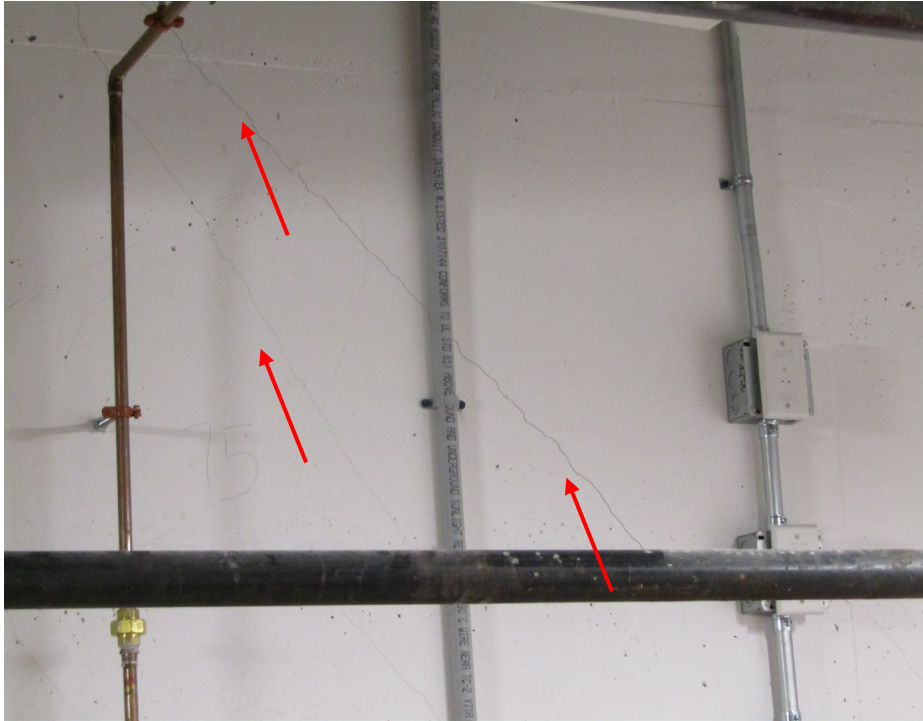
Photo 13 – View of a hairline inside fire pump room wall.

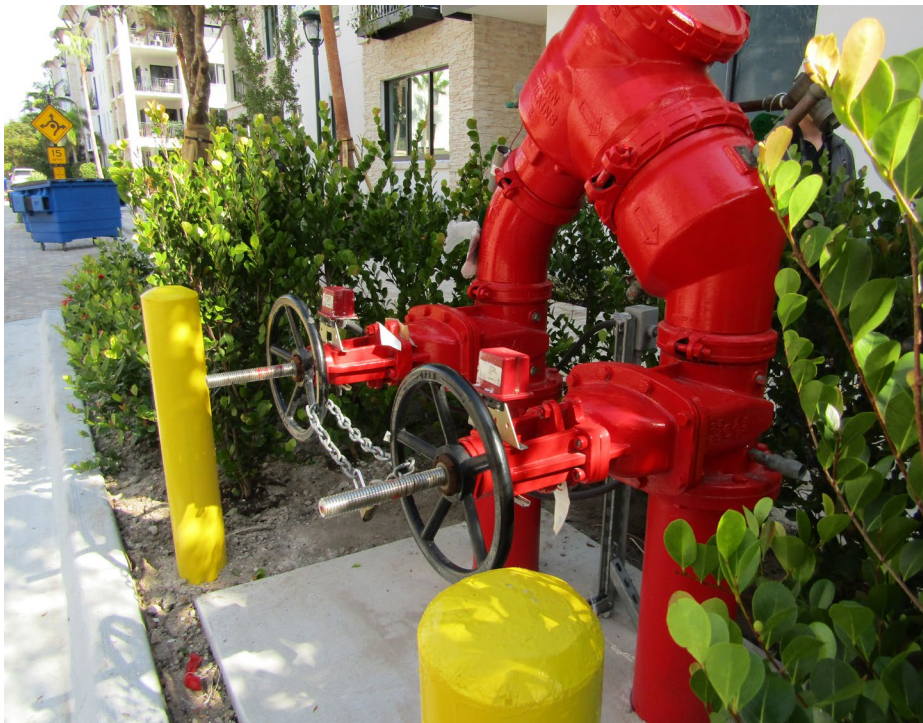
Photo 14 – View of fire sprinkler backflow preventer.

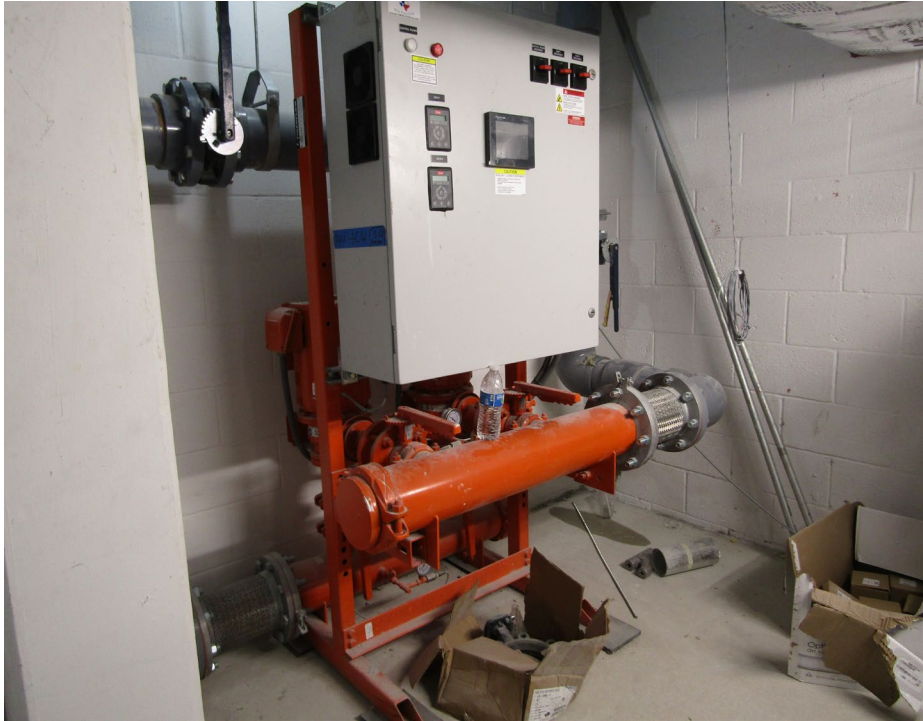
Photo 15 – View of domestic water pump.

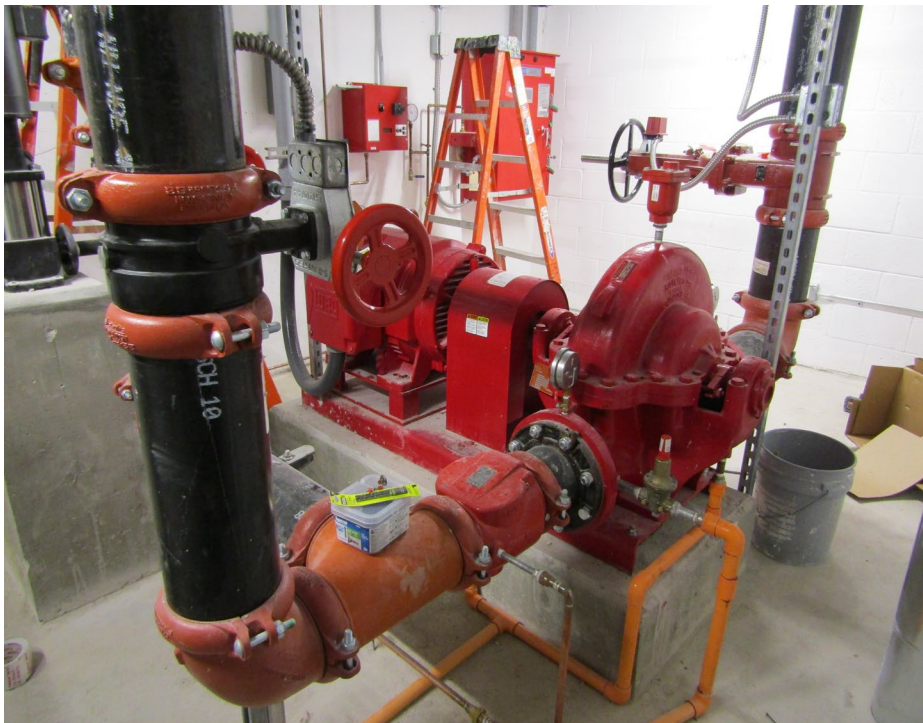
Photo 16 – View of fire pump.

Electric Fire Pump – We assume that the Association is responsible for the maintenance and replacement of the fire pump serving the building’s sprinkler system. It is our understanding that the electric fire pump is original. Typically, fire pumps and controllers of this type have a useful life of approximately 30 to 35 years. We have included a reserve for replacement or repairing of the current system.

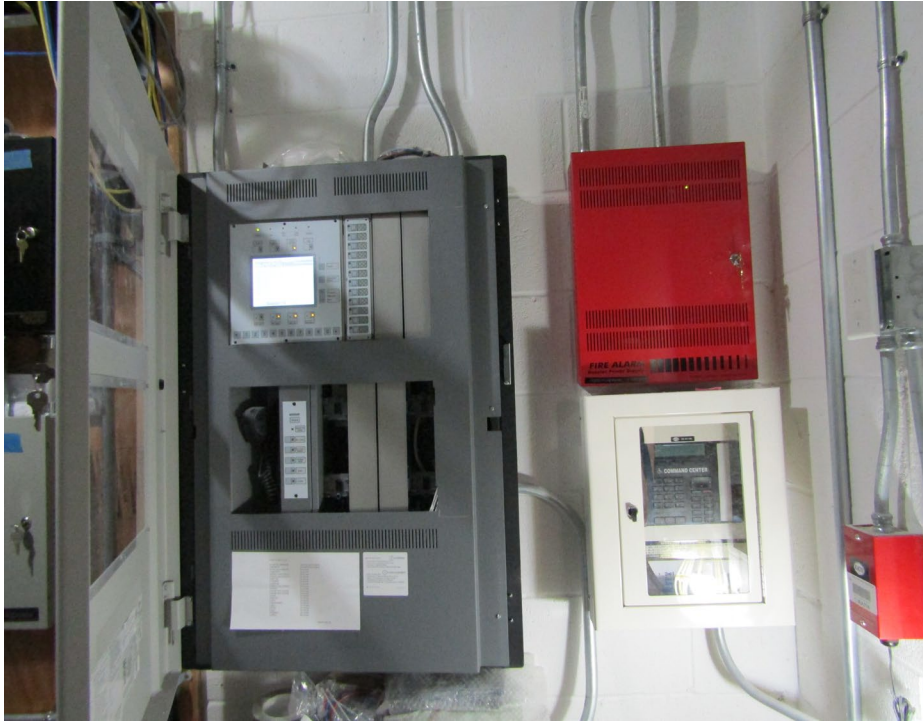
Photo 17 – View of FACP in electrical room.

FACP and Audio/Visual Fire Alarm System and Sprinkler - The fire protection system includes a fire alarm control panel (FACP) numerous audio and visual alarms, standpipe fire sprinkler system, fire alarm pull switches, and fire pump. Typically, these control systems have a typical useful life of 25 to 30 years before requiring an updated system. A reserve has been included for replacement of the FACP and related equipment.

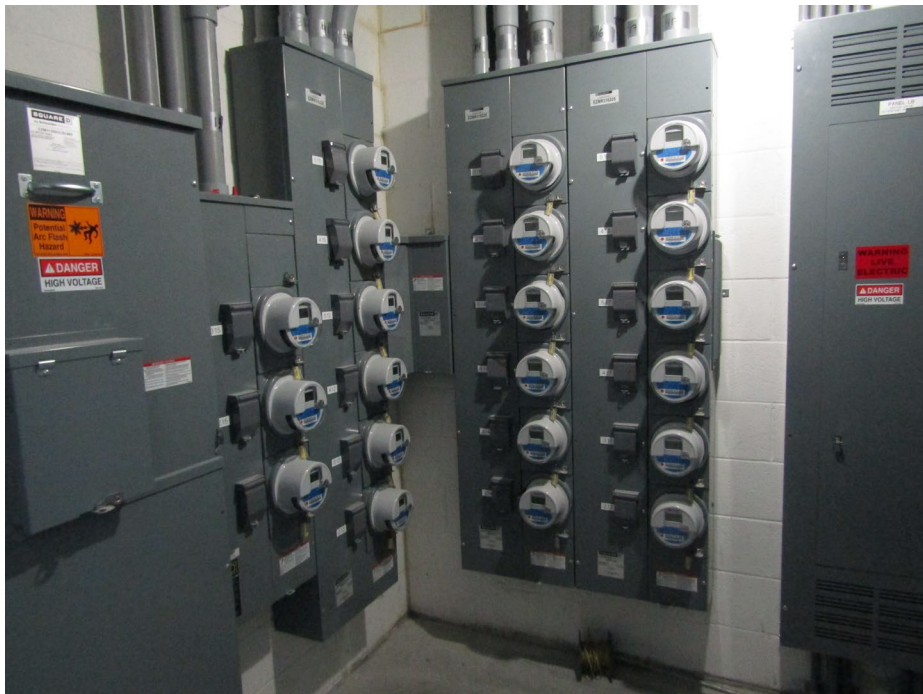
Photo 18 – View of typical meter center in electrical room.

Electrical System – Currently there are no indications of any deterioration or issues with the electrical system for the building. The electrical panels and meter enclosures are located in the meter rooms within the parking garage and are in good condition. Localized breaker panels and branch circuits are typically replaced during common area or individual unit renovations as required to accommodate the renovation. A reserve has been included for periodic replacement/upgrades of major electrical system components such as main service panels and feeder lines.
